# ***Track and Structures***

## ***Track Maintenance Training***

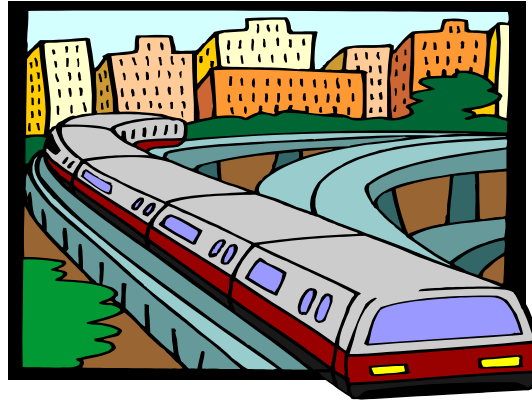
## Section Objectives

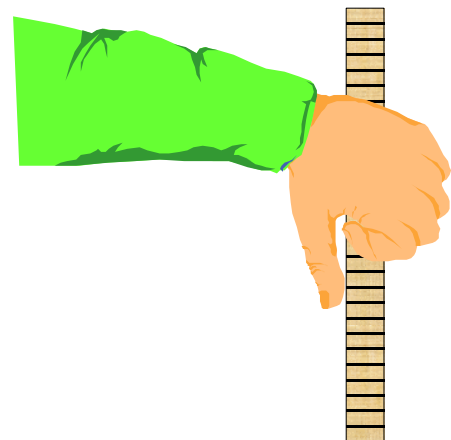
- Defect depth; usually in  $1/1000$  of an inch. This is the value between the top of the rail surface and the bottom of the defect.
- Defect wavelength; for periodic defects, such as corrugations. Defined as the distance between adjacent wave peaks (or valleys) and given in inches.

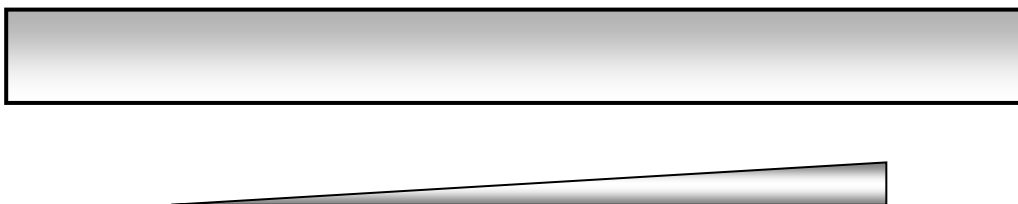
- The 36 inch straight-edge is used as a bridging device. The dial gauges also have an accuracy to +/-0.003 inches.

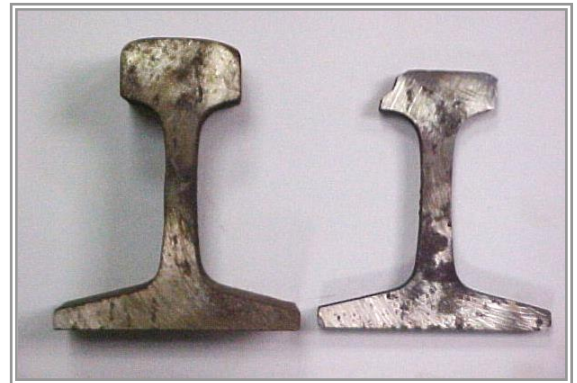
Most rails are eventually scrapped because of wear of one or more types.

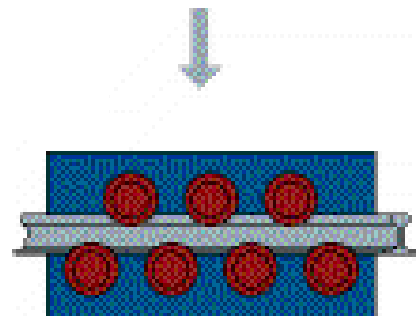
- Load levels are continuously monitored to ensure the production of straight rails without mechanical damage.

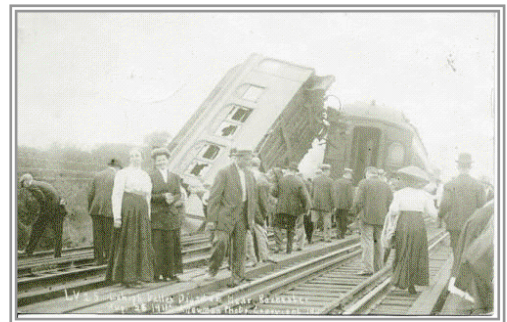
Train operators who either see a broken rail or hear the wheels of their train pounding on the break find some service failures.

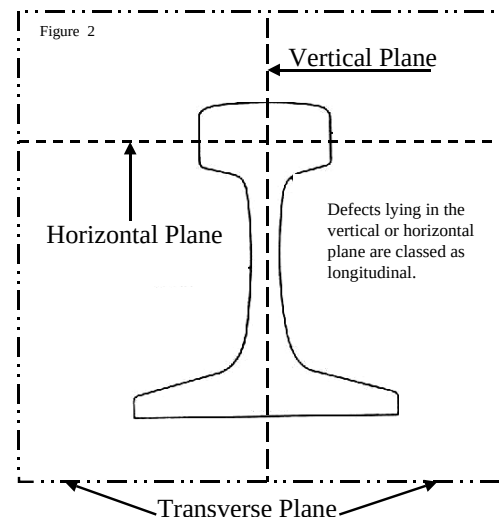
However, this type of inspection cannot detect those internal separations of the steel on the railhead known as a transverse defect, and frequently overlooks horizontal split heads.

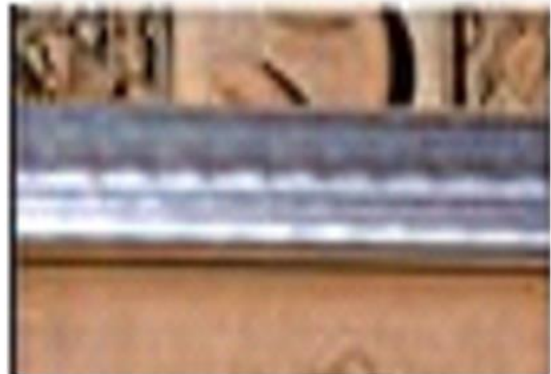
Intermediate wave corrugation or undulations at times could exceed 10 to 12 inches in length.

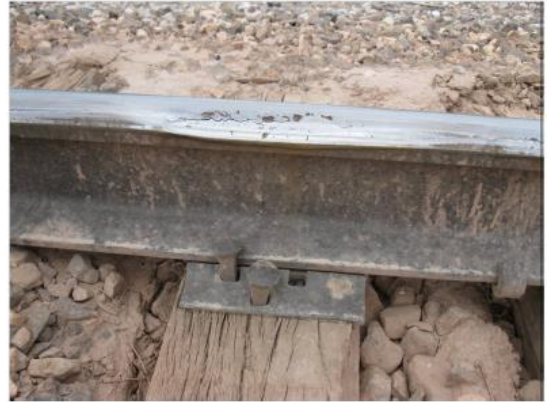
The crushed head usually originates by a soft spot in the steel of the head, which gives way under heavy wheel loads.

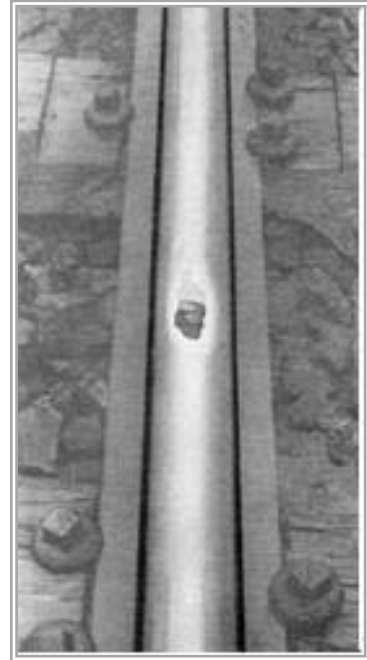
This can be an effective temporary measure until the burn can be welded or the rail replaced. Depending on the severity of the depression, a slow order may be appropriate to reduce impact stresses until the condition can be corrected.

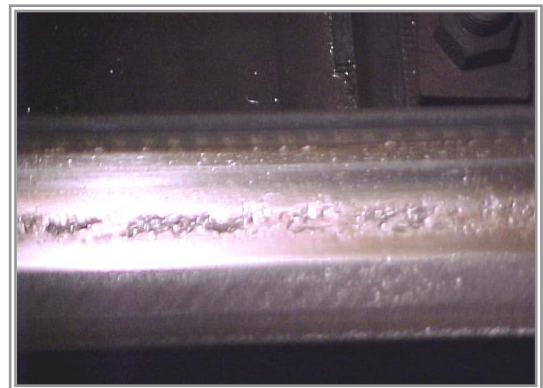
Flaking should not be confused with shelling, as the flaking takes place only on the running surface near the gauge corner of the rail and is not as deep as shelling.

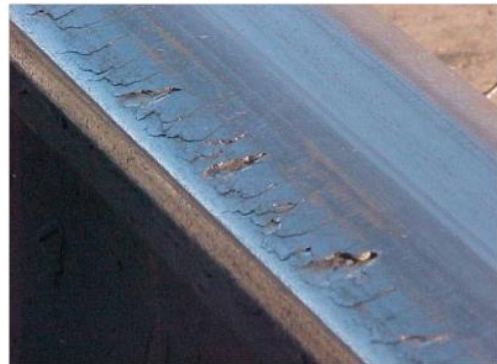
Head checks generally run at a 45-degree angle to the axis of the rail: they usually occur on the high rail of curves. Concentrated wheel loading at the gauge corner of the railhead causes them. Detail fractures can originate from head checks.

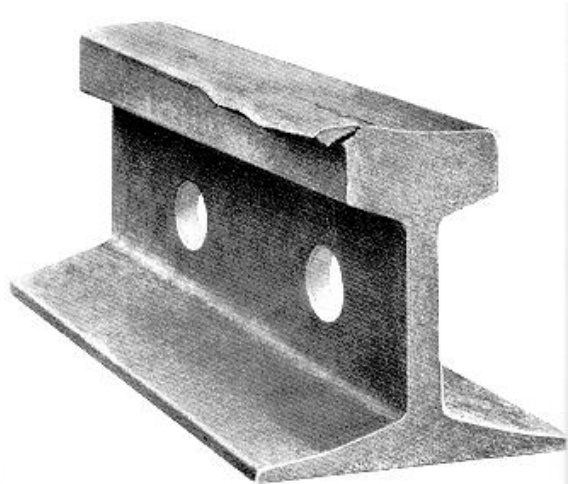
Appearance of flow in rail Photo - Section of rail with head flowed to field side, some of lip cracked or broken off

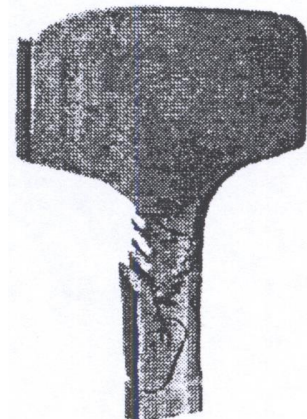
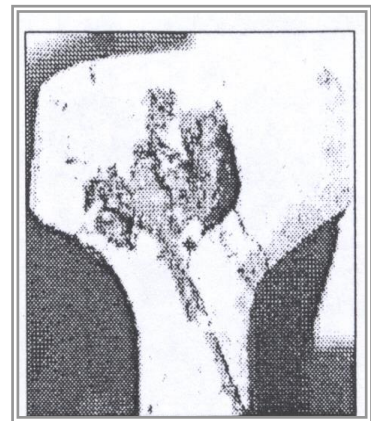
Mill defects are a serious defect if they are deep or large enough to cause the development to increase.

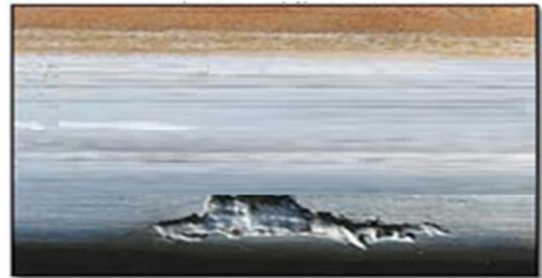
- 1) Dark spots are irregularly spaced on the gauge side of the running surface.
- 2) Longitudinal separation occurs at one or several levels in the upper gauge corner, with discoloration from bleeding.
- 3) If rail is turned, shelling will appear on the field side, with an irregular overhanging lip of metal. Appearance is then similar to flowed metal.

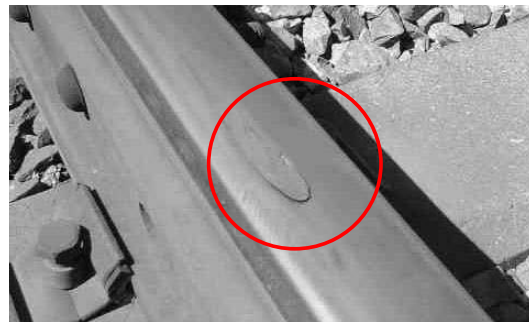
- They are not a serious defect.
  - 1) Thin slivers (similar to wood slivers) are on the Surface of the railhead and parallel to the rail length.
  - 2) Darkened slivers are shown (in advanced stage) giving an appearance much like the vertical split head but without any spreading or crushing of the railhead.
  - 3) Slivers on the side of the railhead. Such slivers may be both shorter and thicker than slivers on the running surface. All slivers are generally less than 1/8, inch thick. They form part of the rail contour, lying flat on a surface, but may be cracked loose from rail metal on three sides. If a sliver has been dislodged, only an indentation will remain on the rail surface.

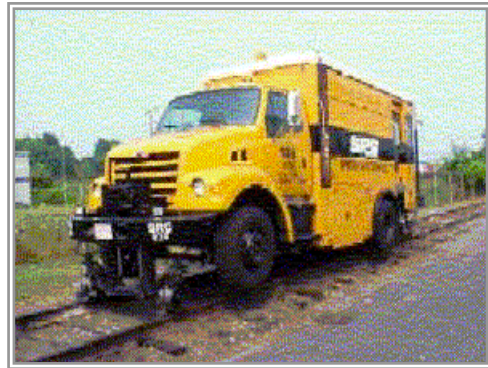
Sperry equipment locates defects that are similar to those that result in many service failures. Frequently, the detection equipment located defects that are entirely internal. Internal defects can usually be accurately classified without breaking the rail.

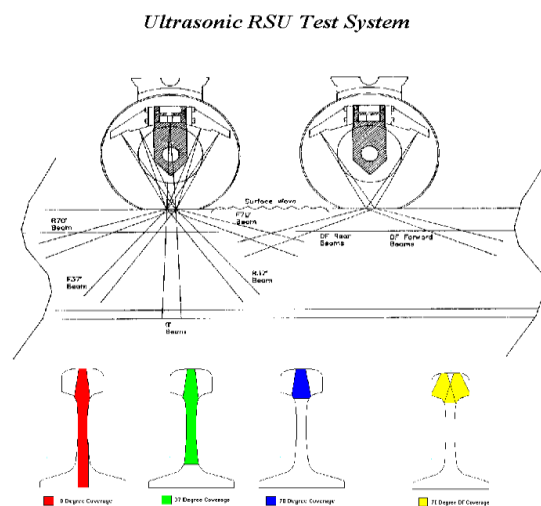
Each of the commonly recognized types of rail failures will be described and discussed. The definitions used are those of the **FRA Track Safety Standards** effective September 21, 1998.

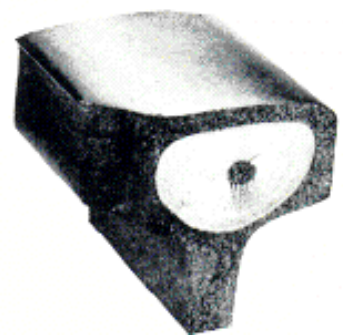
Progressive transverse defects will also develop underneath engine burns or rail welds that have been resurfaced by welding when the area being rebuilt is not properly cleaned or cooled during the process.

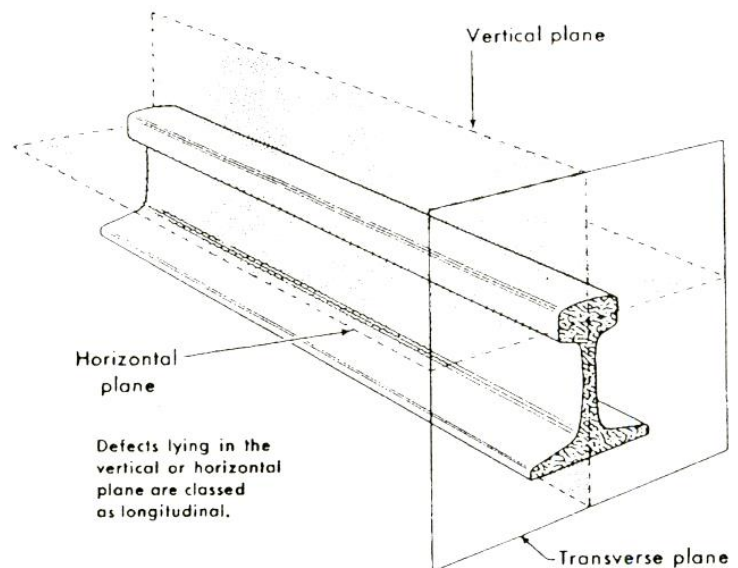
- Shelling can be identified by the presence of a slight discoloration on the gauge side of the running surface. On turned rail, the shelling area may be found at the field side.

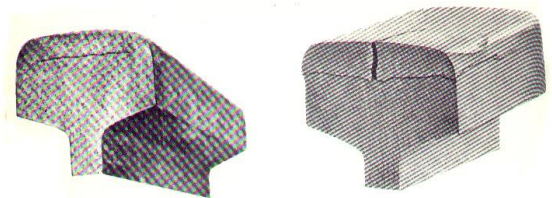
Compound fissures are dangerous for reasons similar to those that apply to the transverse fissure.

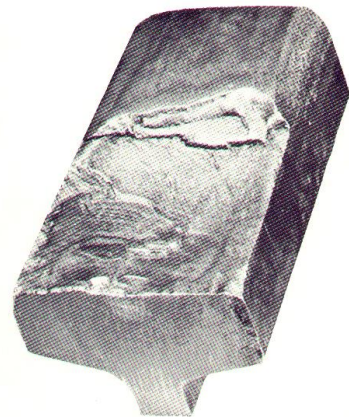
- (a) They can occur at several locations in the same rail.
- (b) In some cases, there is no visible defect until the rail actually breaks.
- (c) When the rail breaks, it is usually a complete transverse break across the entire rail.

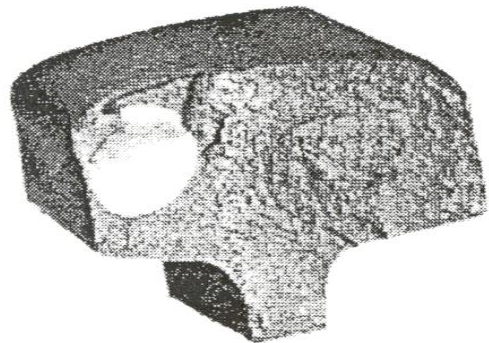
It is possible for a detail fracture to grow quite quickly. Failure often takes place before there is any visual evidence of the defect. Like the fissures, detail fractures lead to a complete transverse break across the entire rail.

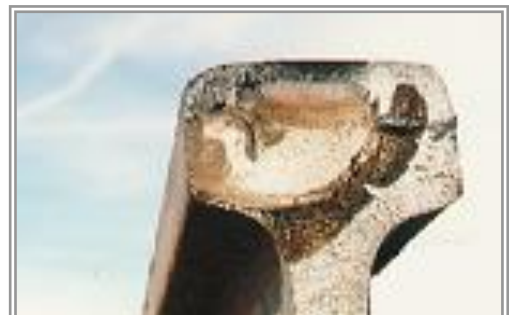
The detail fracture from head check is a progressive fracture starting at the gauge corner of the railhead and spreading transversely through the head. It originates in the upper gauge corner of the rail, usually caused by the

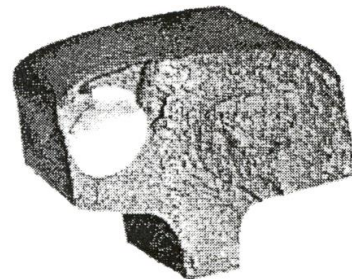
The separation progresses longitudinally, not as a true horizontal or vertical crack, but at an angle related to the amount of rail wear on the gauge corner.

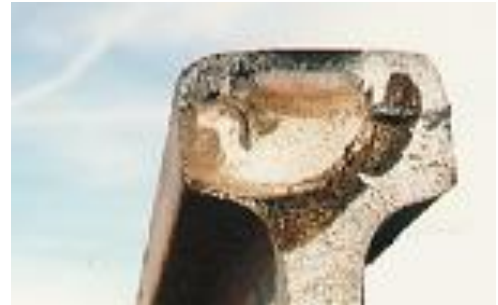
## 8. Reverse detail fracture

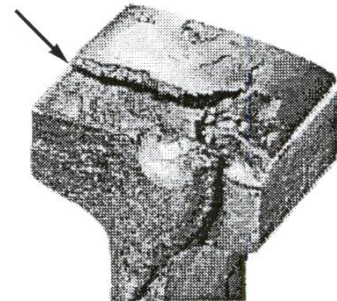
If severe slippage of train or locomotive wheels occurs, each driving wheel will create a surface defect on the head of the rail on which it is supported.

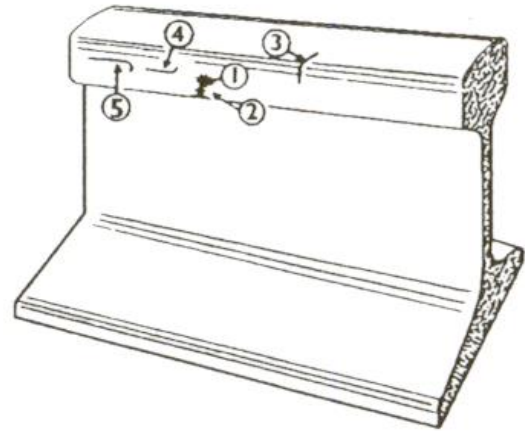
**Appearance in Track** - No sign of a transverse separation is visible until the defect reaches the rail surface (cracks out). An engine burn fracture may then be recognized by one or more of the following characteristics identified in the reference material listed below.

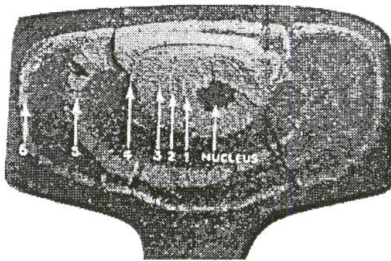
The transverse fissure can be readily identified after a complete break occurs, by the presence of a nucleus within the defect.

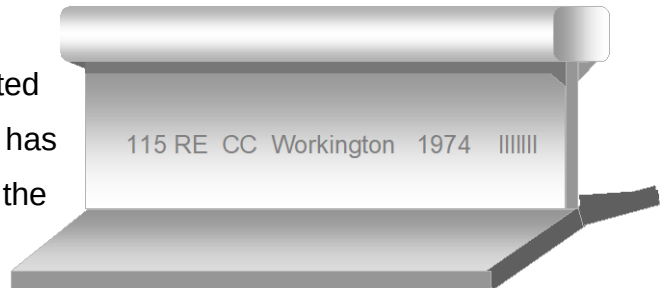
Most railroads still have substantial quantities of rail in track that is not control cooled. Such rail can be identified in two ways.

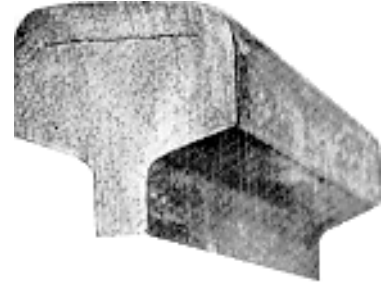
- Rail that has been relayed or otherwise disturbed after years of service in one position is particularly susceptible to the development of longitudinal defects due to altered stresses and changed loading patterns.
- It has been noted that wheel-to-rail loading changes, which result from contour grinding, have aggravated certain dormant rail conditions.

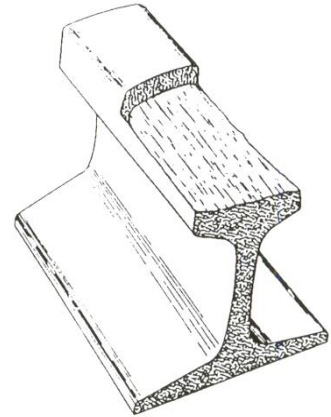
Evidence of horizontal split heads is usually visible before failure occurs. In the first stages, a flat spot or dip usually develops on the top of the railhead. There may be a slight widening of the head.

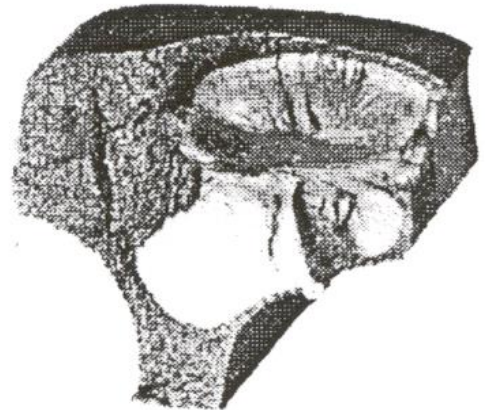
## 19. Vertical split head

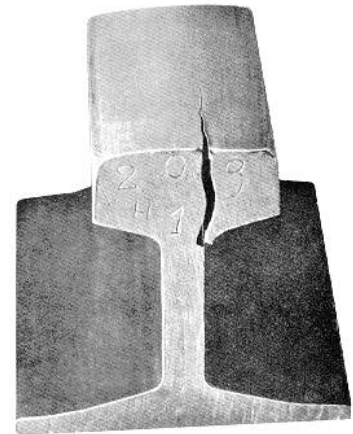
- (1) A dark streak on the running surface.
- (2) Widening of the head for the length of the split. The side of the head to which the split is offset may show signs of sagging or dropping.
- (3) The dropping of the head causes a rust streak to appear on the fillet under the head.
- (4) In advanced stages, a bleeding crack will be apparent at the fillet.

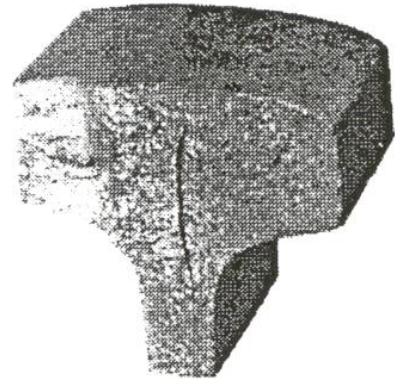
- Upon service failure the rail may break into several pieces.

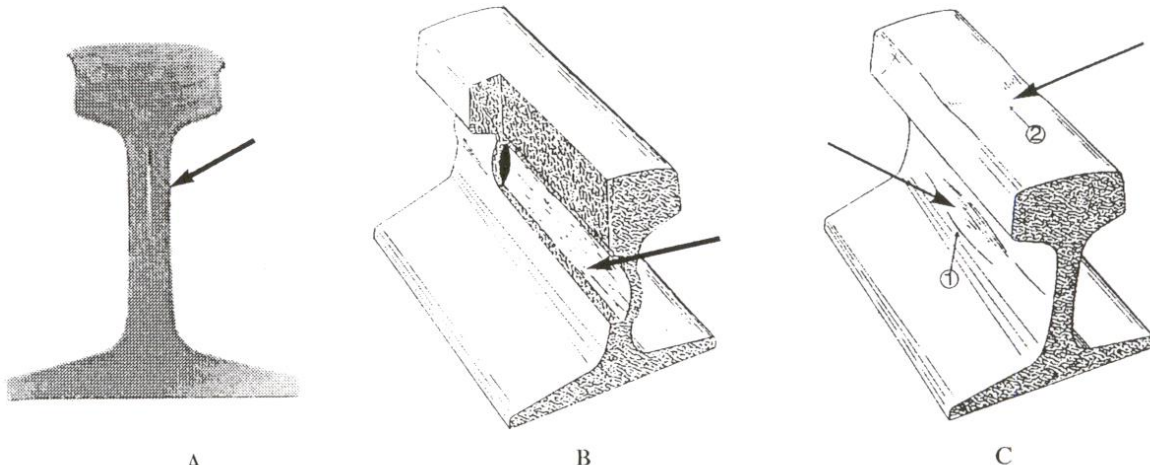
Piped rail is not a commonly found defect. The origin is a wide longitudinal seam or cavity inside the web, which extends vertically toward the head and base of the rail.

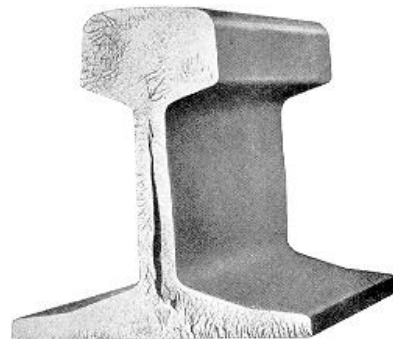
- Bolt hole crack
- Head and web separation

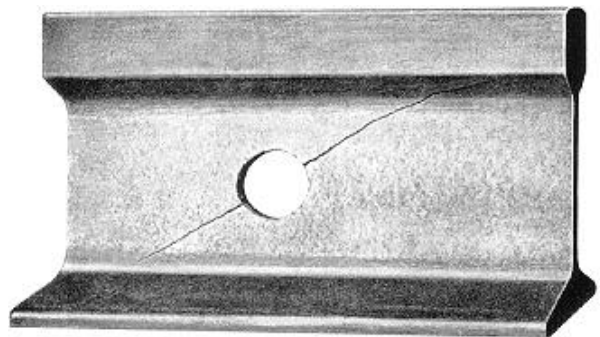
- Occasionally, the cracks may progress beyond the joint bars and cause a complete transverse separation.

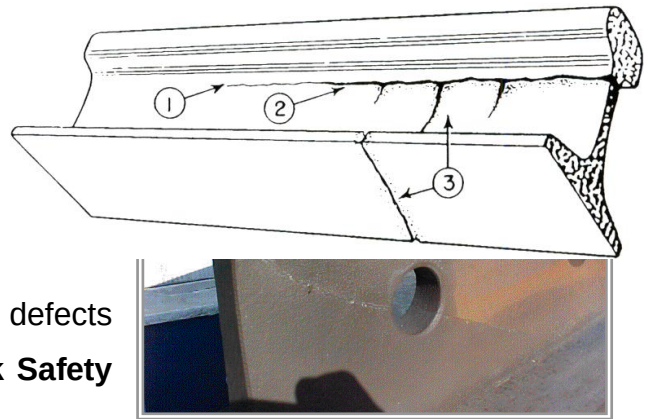
## 7. Head and web separation

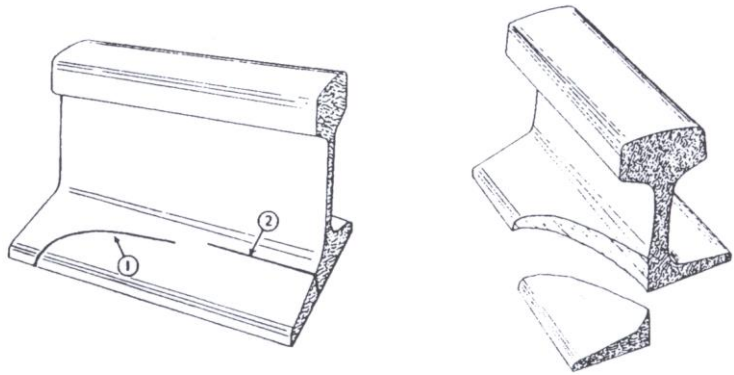
A nick or blow on the edge of the base that results in an indentation or step usually cause the base fractures.

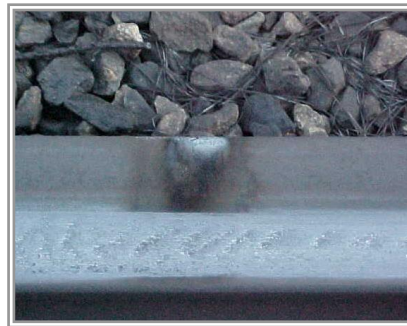
Track workers carelessly using a spike maul while spiking, or striking the rail while adjusting expansion may cause some nicks. Other nicks on the head of the rail are caused by broken wheels and these could be serious.

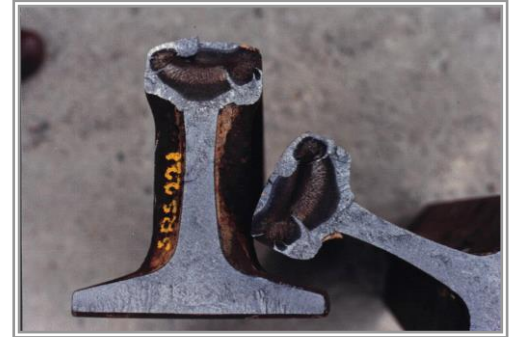
A defective weld is most frequently a transverse defect, but sometimes, it is a longitudinal or split web type of defect, which can grow until complete failure occurs.

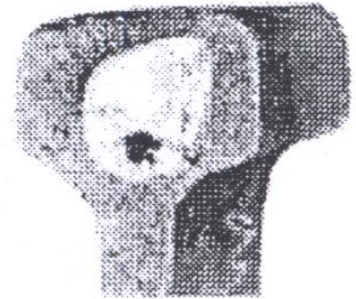
Web defects on a longitudinal plane through the weld may result from stress risers at shear drags, grinder gouges or residual stresses in rail ends prior to welding.

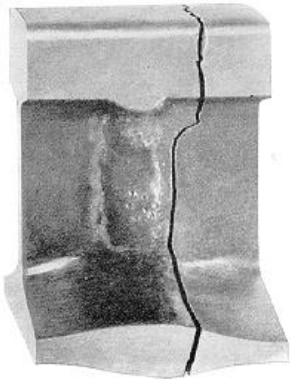
A defective field weld may be either a progressive fatigue fracture or an internal weld discontinuity that occurs as a result of improper weld materials or procedures.

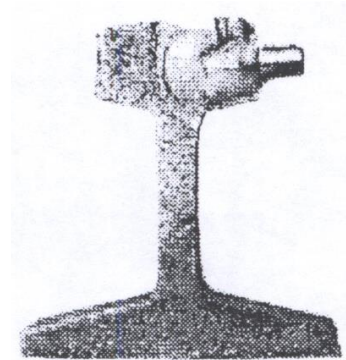
Progression of longitudinal cracks in the mid-web area is usually extremely rapid.

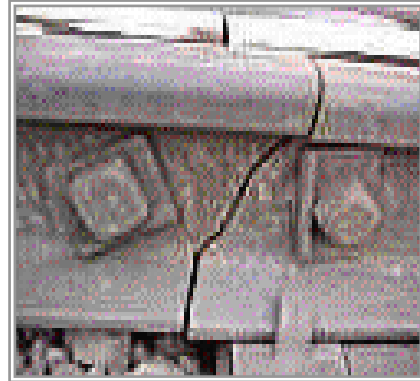
The face of the rail shows a polished transverse defect with typical growth rings that have the appearance of gradually enlarging semi-circles with the center or focal point at a welded bond connection.

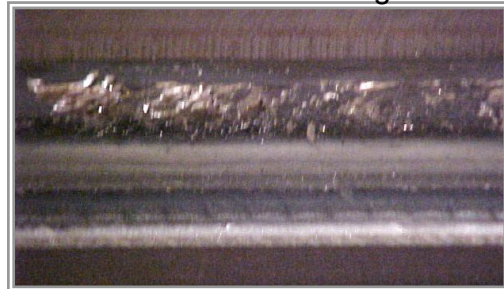
This general classification includes defects which can be identified on the surface of the rail:

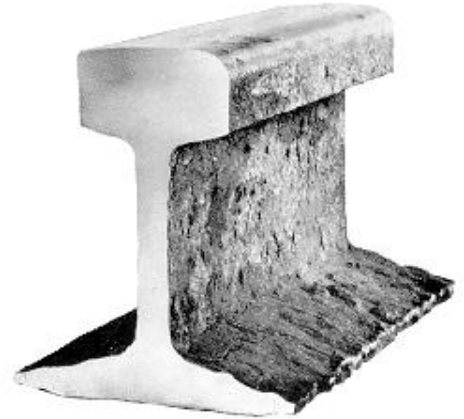
The corrosion is usually a slow process that occurs over an extended period of time. However, this process is greatly accelerated by electrolytic action on railroads where electricity is the primary means of motive power.

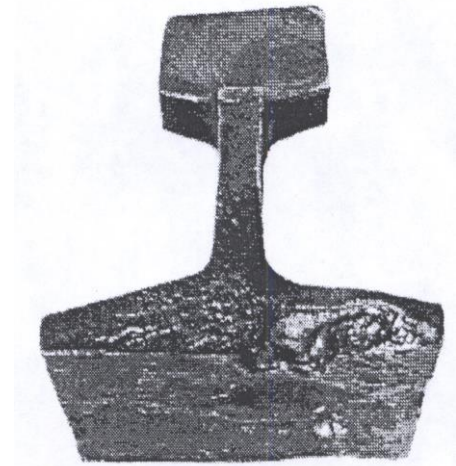
Water can accumulate on both the rail base and the rail fastener under these conditions.

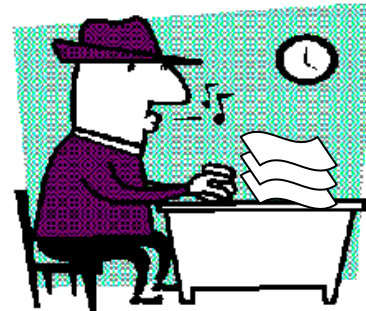
It should be remembered, however, that it is not necessary to memorize the standard. When confronted with a defective rail in track
